marantz

SERVICE BULLETIN

SS-MAR0234

model number 10B	bulletin number M-10B-2
for serial numbers ALL	
subject WARM UP TRANSIENTS	
engineering approval <i>[Signature]</i>	date 6/17/76

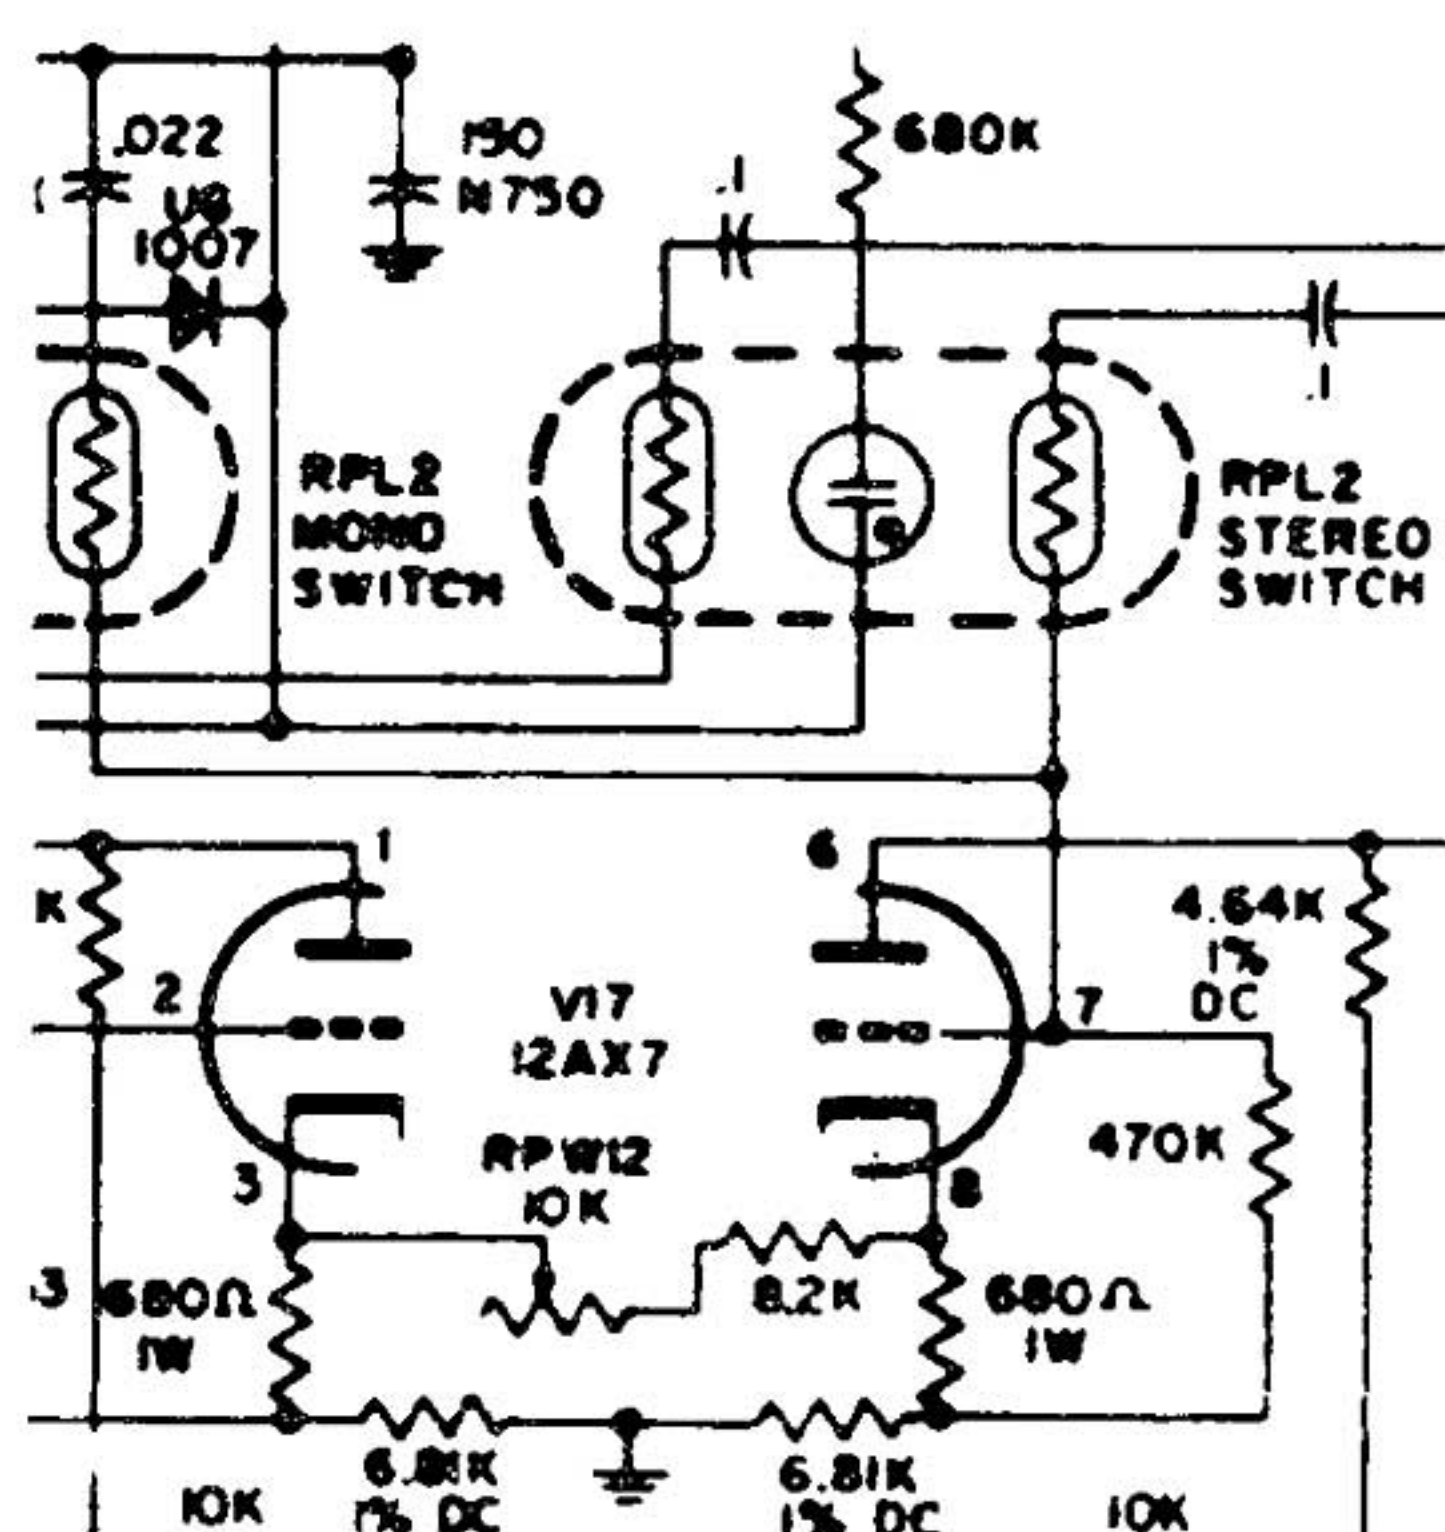
ORIGINAL

If you receive customer complaints regarding strong pop transients from the Marantz Model 10B during warm-up, the following modification is recommended.

At Stereo Switch RPL2, install two 470K ohm 1/4 W resistors (part number 434-6472) as shown below:

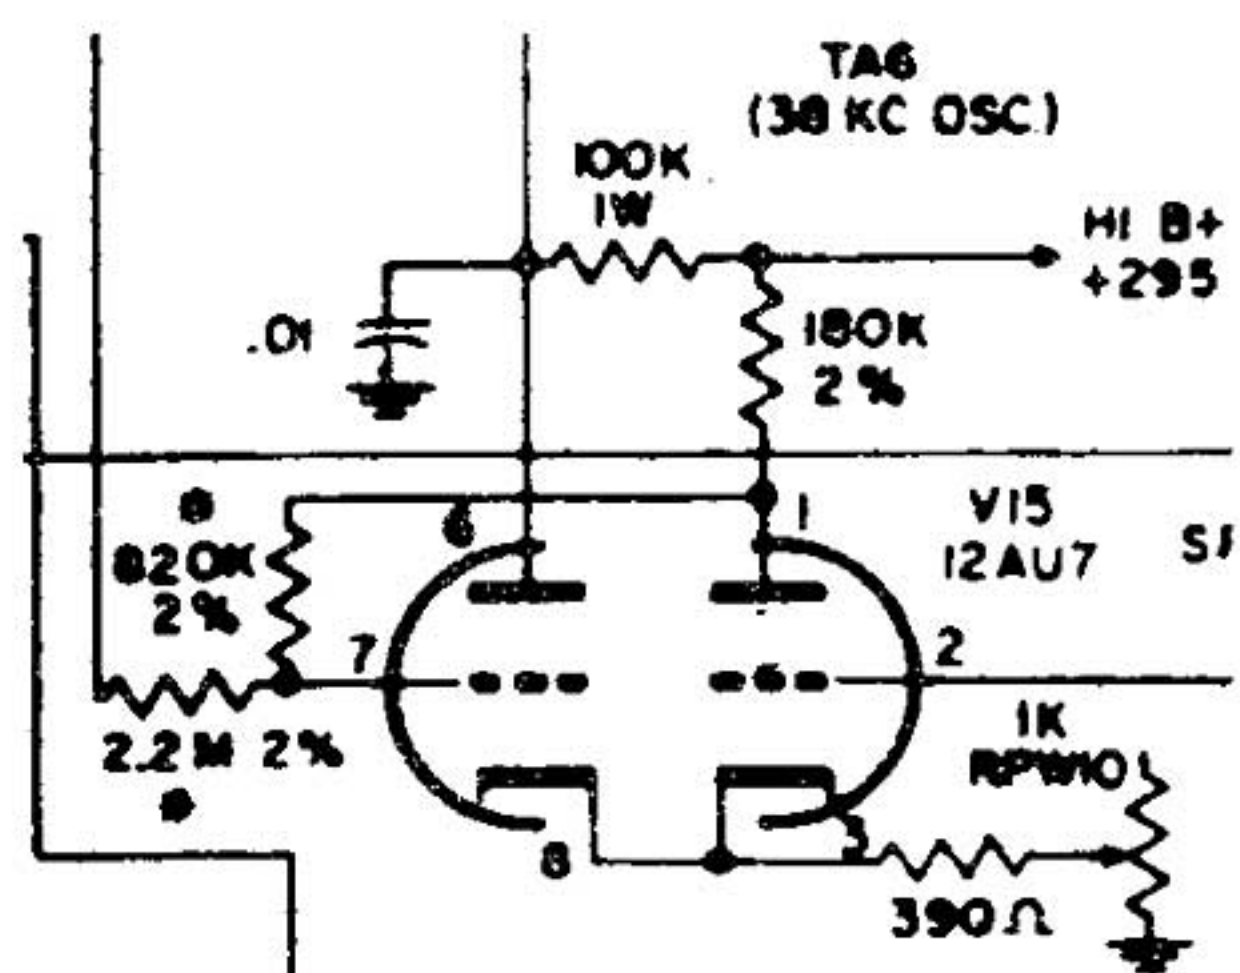
ORIGINAL

If a click noise occurs when the stereo indicator lamp is activated, it is recommended a .03 uF 450 V capacitor be installed at V15 as shown below:
