SERVICE BULLETIN

model number 4240	bulletin number M-4240-A
for serial numbers Below 100001	
subject Elimination of AC Line Switching Transients	
engineering approval <i>E. Leggett</i> <i>(Signature)</i>	date 10-7-74

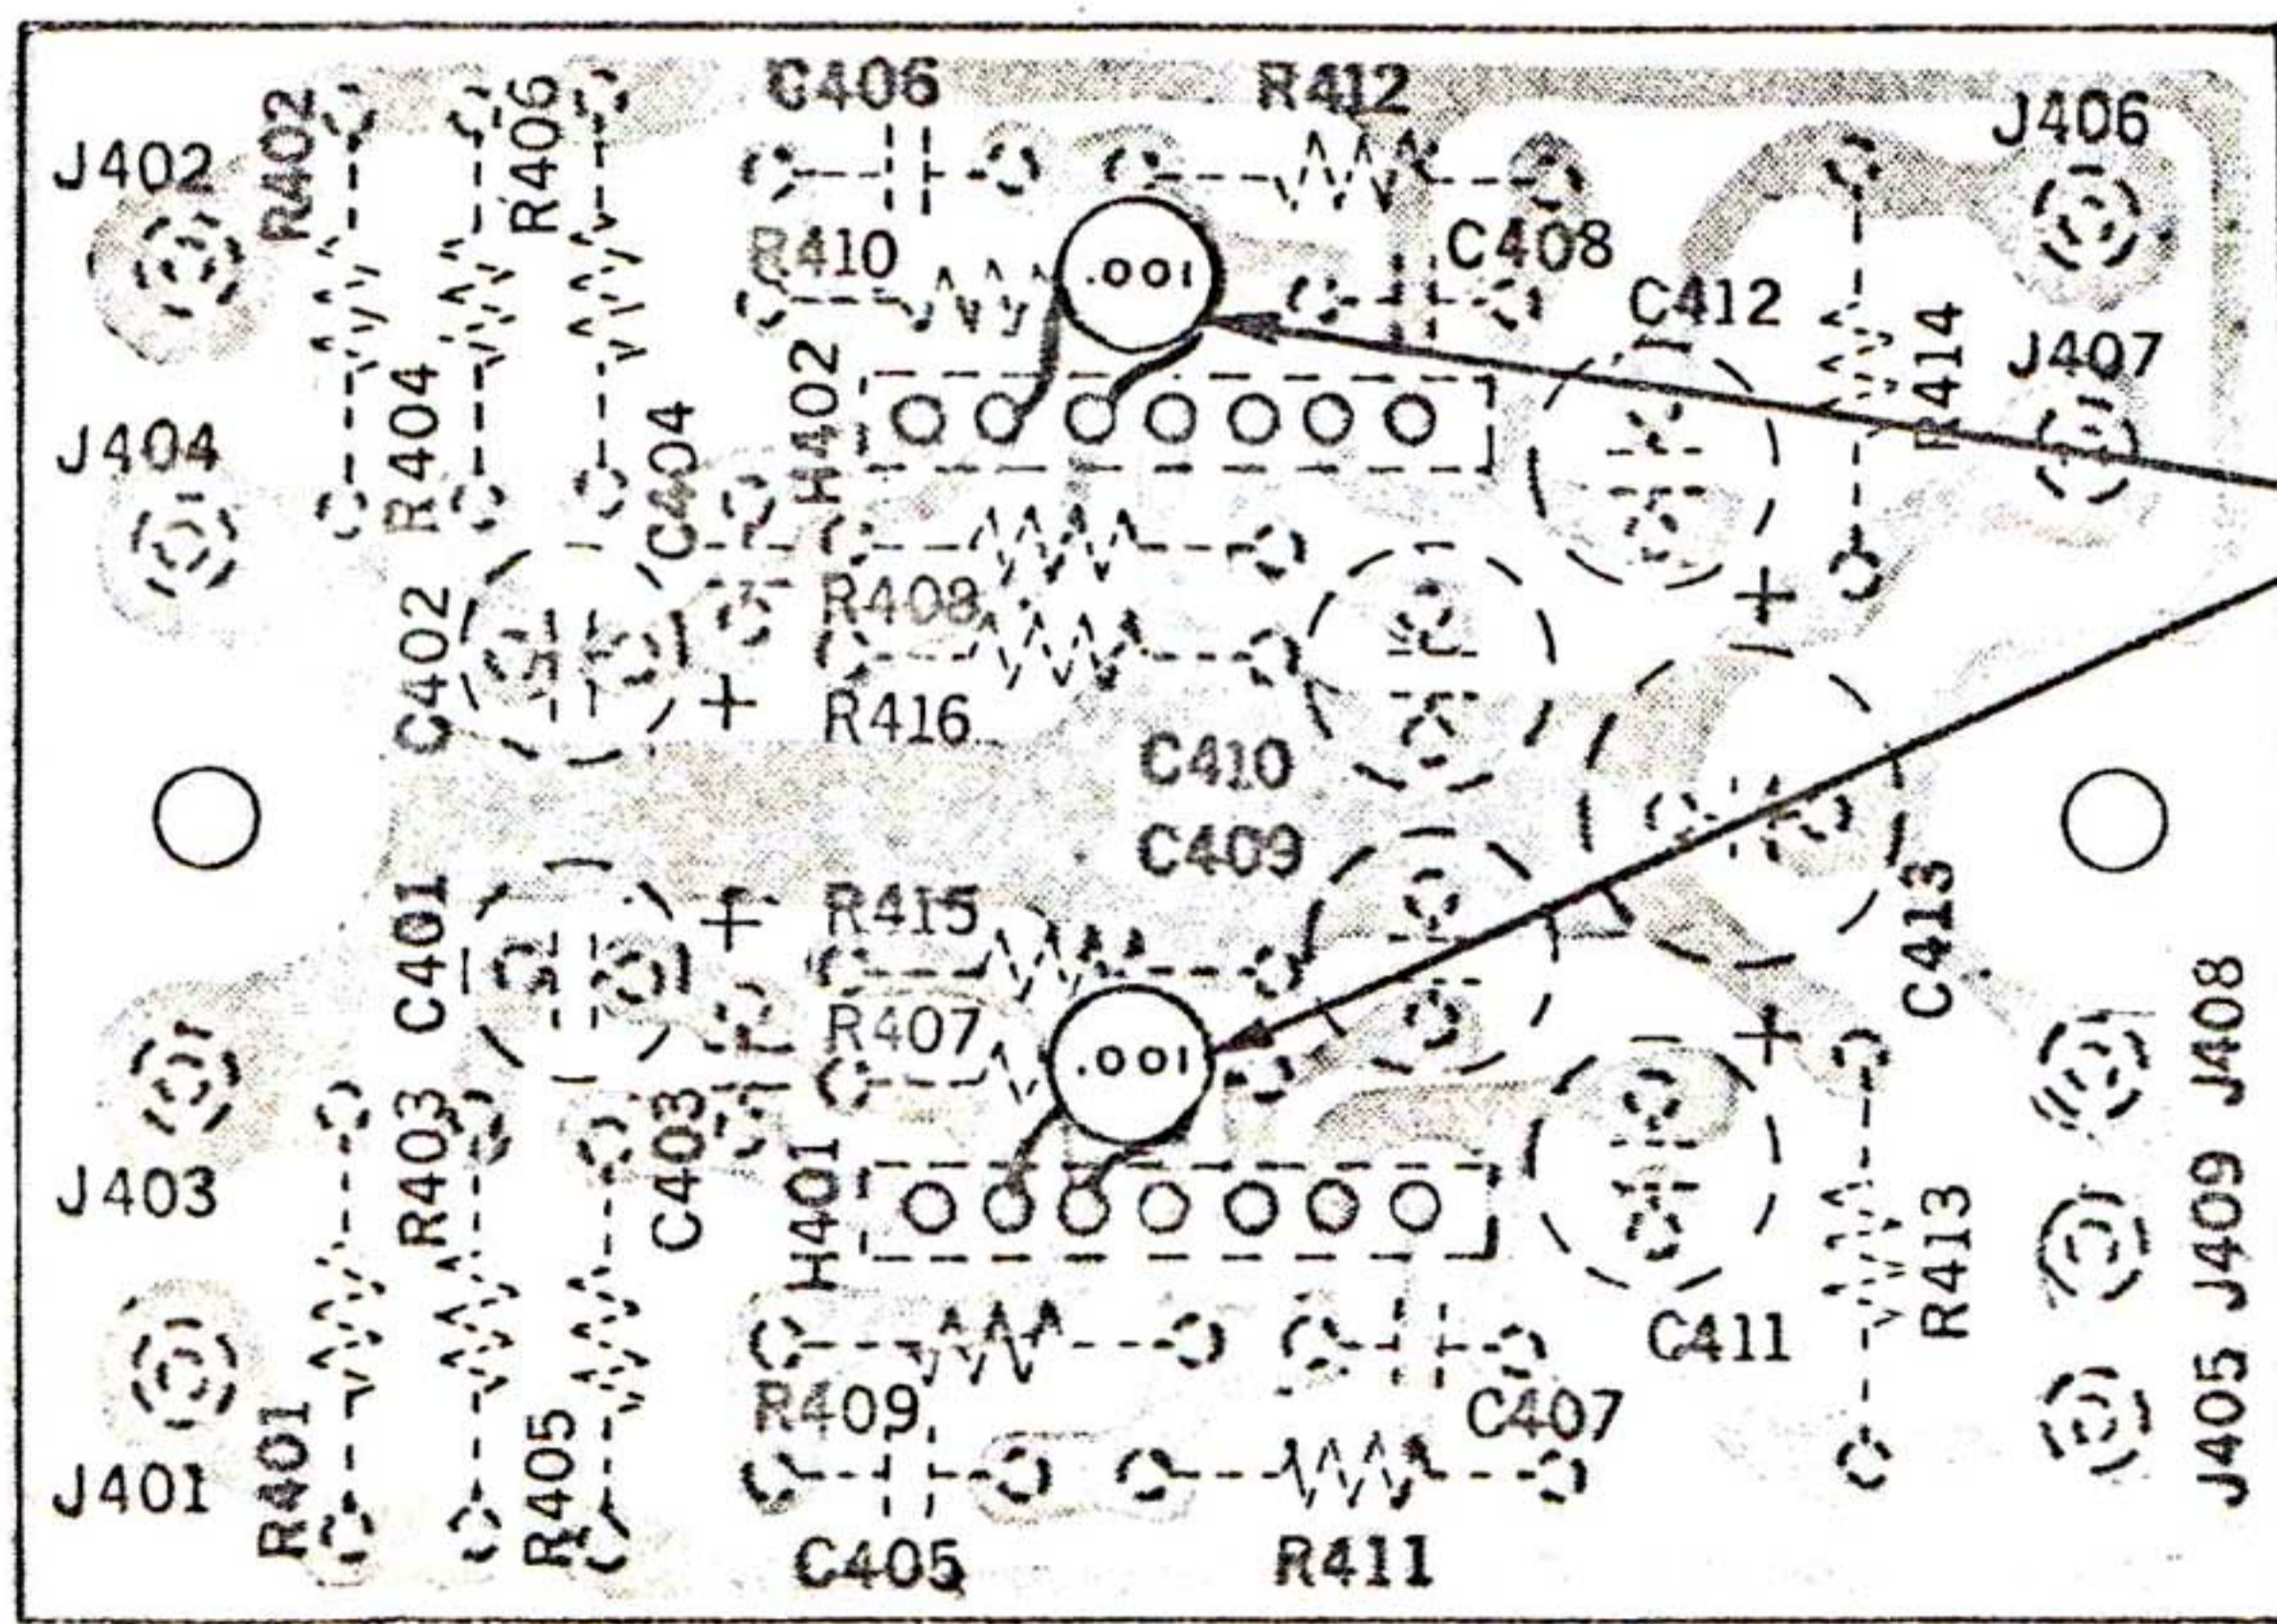
Fig. 1A

In some homes AC line switching transients from home appliances, such as refrigerators, may cause an audible "pop" to be heard in the speakers. The transient is transmitted via the house wiring.

1. Connect a 1000pF ceramic disc capacitor between pins number 2 and 3 of IC H401 and IC H402 on the foil side of the Phone Preamp Board, (See figures 1A and 1B).
