### QUAD 44 ERRATIC INPUT SWITCHING

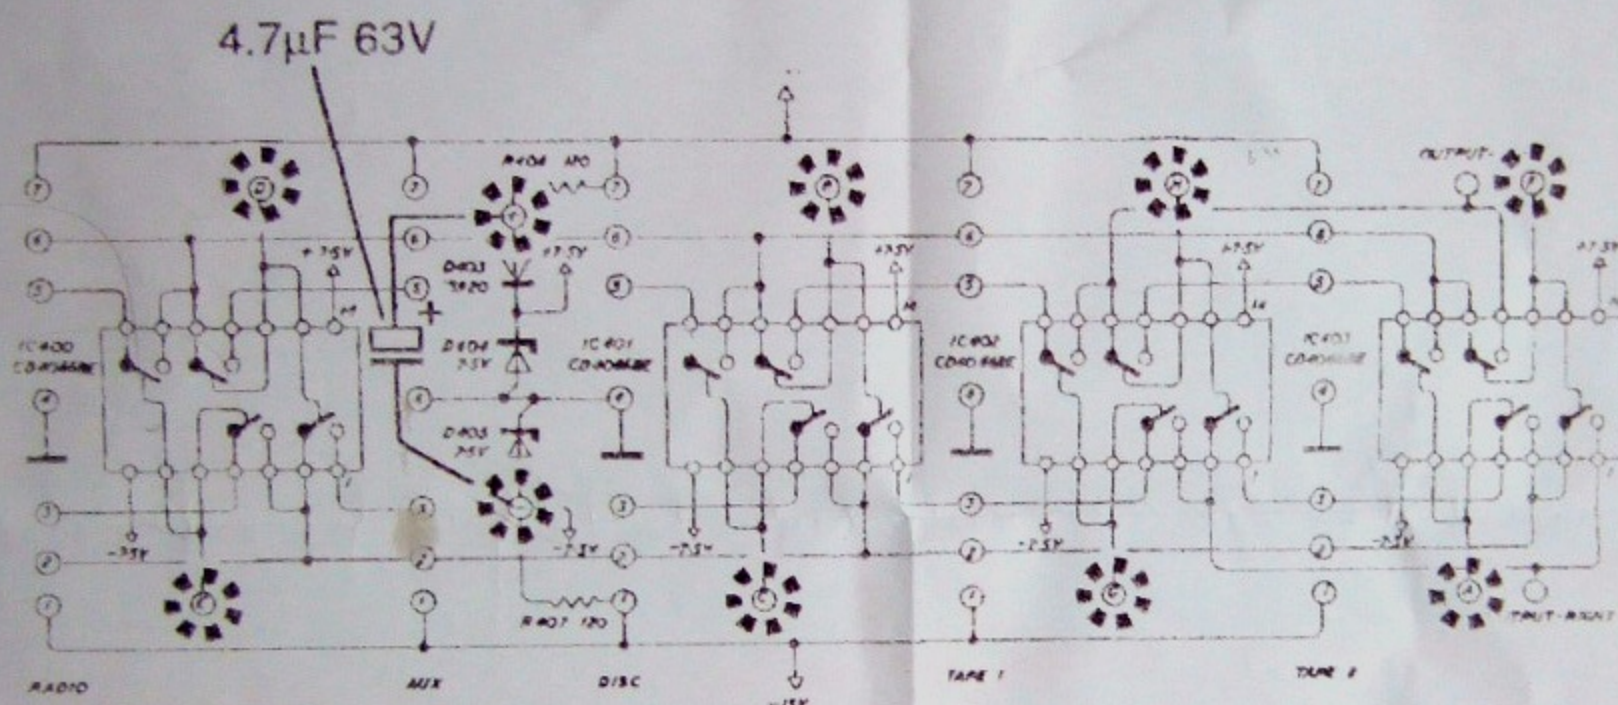
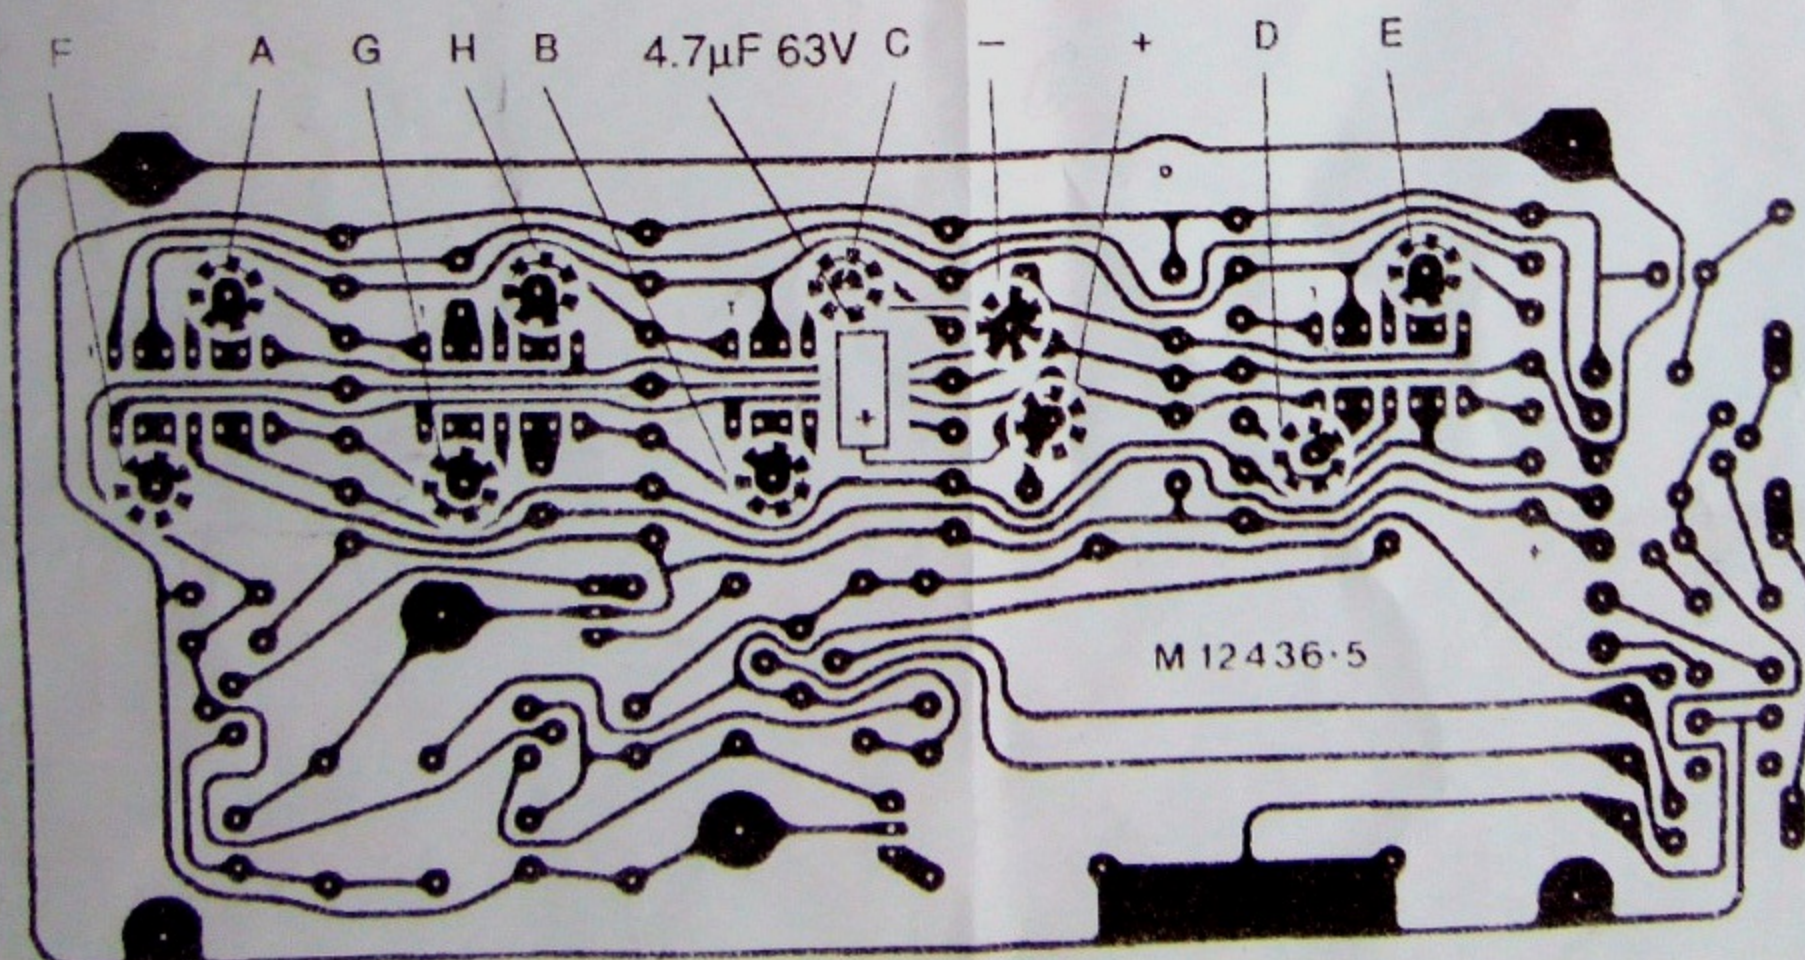
A small number of 44 control units appear to be subject to pulses, triggering the electronic switching causing the unit to change from the input selected either to another input or to no input at all. The required input can then be regained by pressing the appropriate input selector button. The cure is to:

1. Resolder both sides of the 10 feed through pins marked D, E, +, -, B, C, H, G, F and A on the mother board. Ideally the pins should be replaced with tinned copper wire. These are ringed

in the diagrams below.
2. Connect a capacitor min  $4.7 \mu\text{F}$  (C4U70ZA) across the +8.5V and -7.5V rails on the back of the mother board, as shown below.
